**DEPARTMENT OF TRANSPORTATION**

Contract #: 04-0120F4Cty: SF/ALA Rte: 80 PM: 13.2/13.9File #: 69.28**WELDING INSPECTION REPORT****Resident Engineer:**Pursell, Gary**Address:** 333 Burma Road**City:** Oakland, CA 94607**Report No:** WIR-003902**Date Inspected:** 12-Sep-2008**Project Name:** SAS Superstructure**OSM Arrival Time:** 1400**Prime Contractor:** American Bridge/Fluor Enterprises, a JV**OSM Departure Time:** 2230**Contractor:** Zhenhua Port Machinery Company, Ltd (ZPMC), Changxing Island **Location:** Shanghai, China**CWI Name:** Fu Yu Hong**CWI Present:** Yes No**Inspected CWI report:** Yes No N/A**Rod Oven in Use:** Yes No N/A**Electrode to specification:** Yes No N/A**Weld Procedures Followed:** Yes No N/A**Qualified Welders:** Yes No N/A**Verified Joint Fit-up:** Yes No N/A**Approved Drawings:** Yes No N/A**Approved WPS:** Yes No N/A**Delayed / Cancelled:** Yes No N/A**Bridge No:** 34-0006**Component:** OBG**Summary of Items Observed:**

OBG Deck Panel repairs at DP-049-001 welds 1 thru 10.

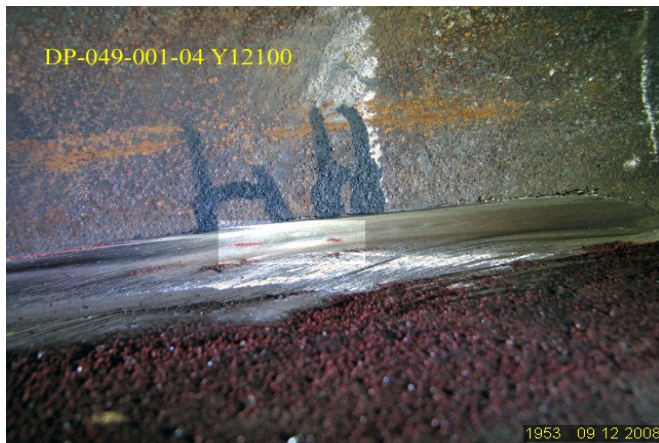
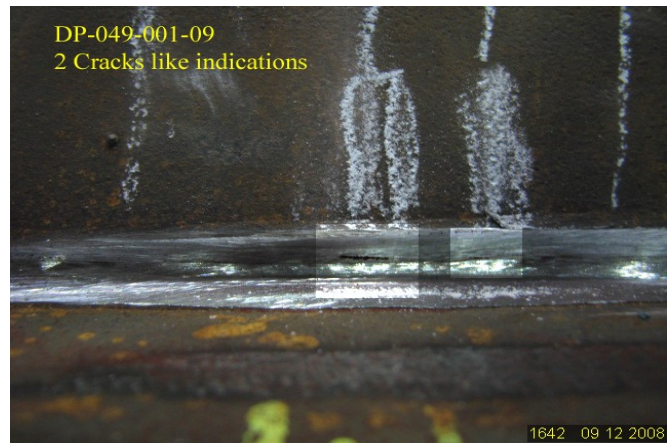
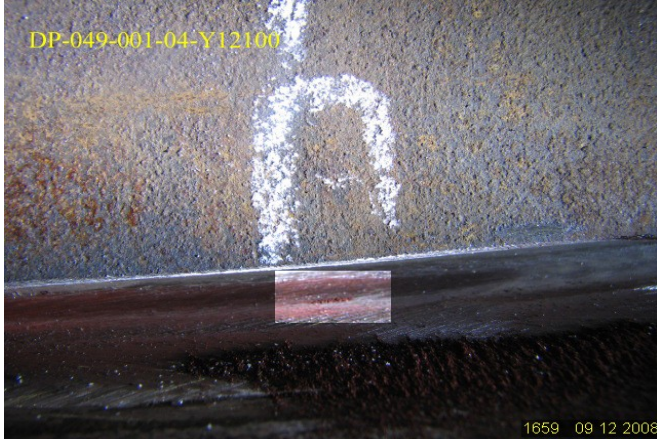
Note: After ZPMC excavate 15 areas marked by QA inspectors for crack like indications on the tack welds the QA inspector observed visually 5 cracks like indications. 5 indications were reported by ZPMC MT technician Wang Wei and CWI Li Yan Hua. See attached indication below.

The QA inspector performed UTPA to 7 locations the QA inspector found 2 crack like indication remains weld # 3 Y location 7320 mm and weld # 9 Y location 10260 mm.
